AFFDL-TR-75-27  
ADA 018 751

## STATIC AND FATIGUE TESTS OF F-111B BORON WING TIP

JUNE 1975

TECHNICAL REPORT AFFDL-TR-75-27  
FINAL REPORT FOR PERIOD JUNE 1969 – DECEMBER 1969

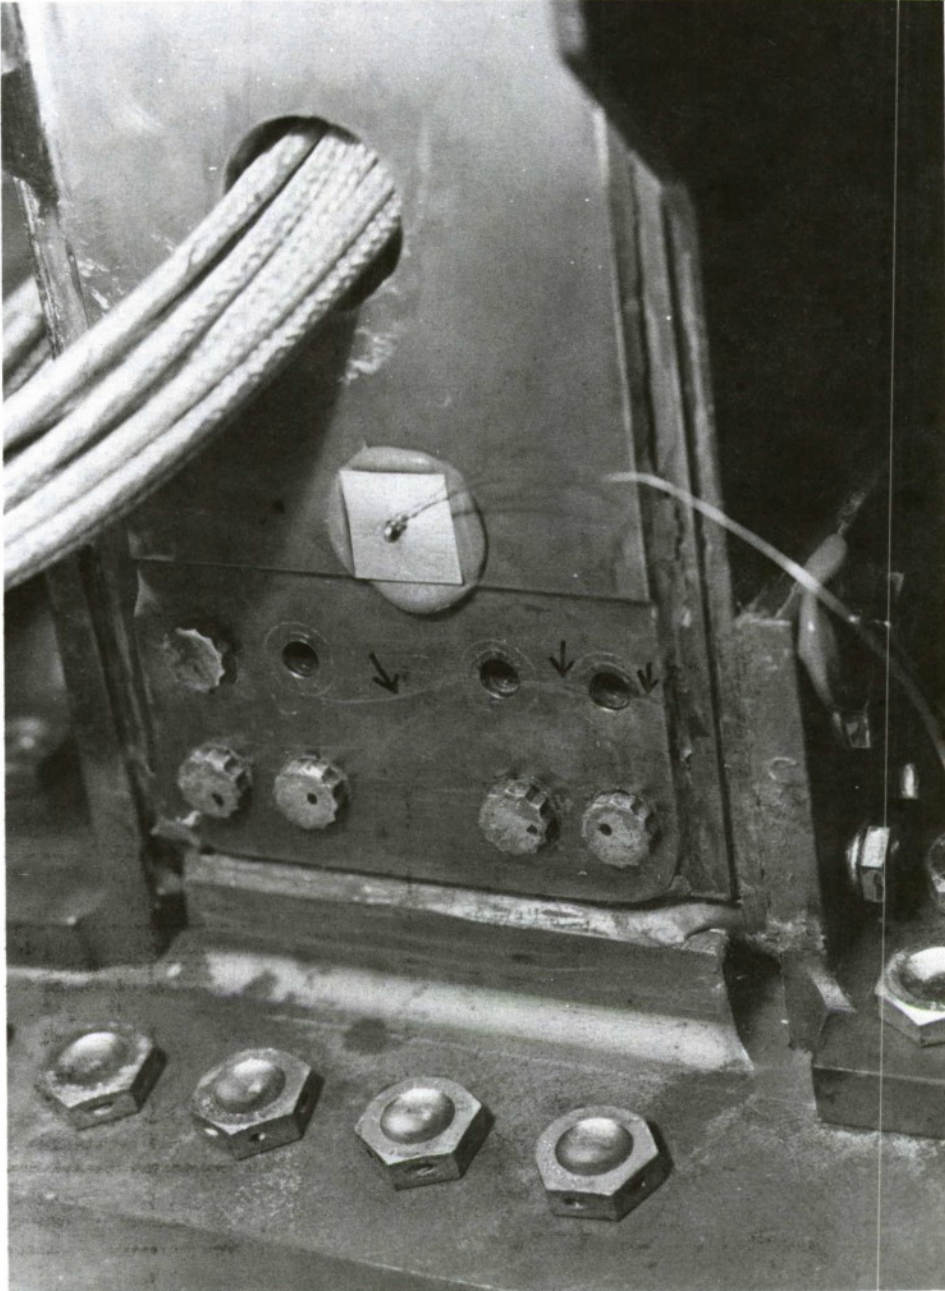
(1) A fatigue crack carried through a titanium doubler plate on the forward face of the front spar. Figure 12 shows the crack between the fasteners.

(2) The lower outboard fastener in a pattern of eight had failed in fatigue through the doubler plate.

A survey of the front spar shear stresses indicated that as the test progressed a greater portion of the shear was progressively carried by the forward face of the front spar, until Block 20 when a decrease occurred. The timing of these occurrences indicates that the mid spar failure occurred after the front spar failure. The failure is likely to have originated in the bond between the aft face of the boron and the titanium cap (Failure No. 6). As the bond line deteriorated, a greater portion of the load was carried by the forward face. This is substantiated by the increased shear stress in the forward face of the front spar web. The greater load in the forward face caused the bolt to fail (Failure 2). As a result, the titanium plate was over loaded and cracked (Failure 1). The load then transferred to the rear face, at the inboard end, and produced a bond failure between the boron and honeycomb core (Failure 3). With failure of both faces of the front spar at the inboard end, the load could no longer be transferred to the test fixture. The load, seeking another path to the test fixture, overloaded the front spar web of the mid rib (Failure 5). The load then redistributed itself through the outboard rib to the mid and aft spars and produced the mid spar failure (Failure 7).

Figure 12. Block 21 Failure of Front Spar Doubler

The front spar failures No. 1, 3, 4, 5 and 6 were repaired by adding a 5/16 inch thick aluminum doubler plate which reinforced all the damaged areas on the front spar. Figure 15 shows this doubler plate installed.

The eight studs on the inboard end of the doubler (Failure No. 2) were replaced after Blocks 21, 30 and 40.

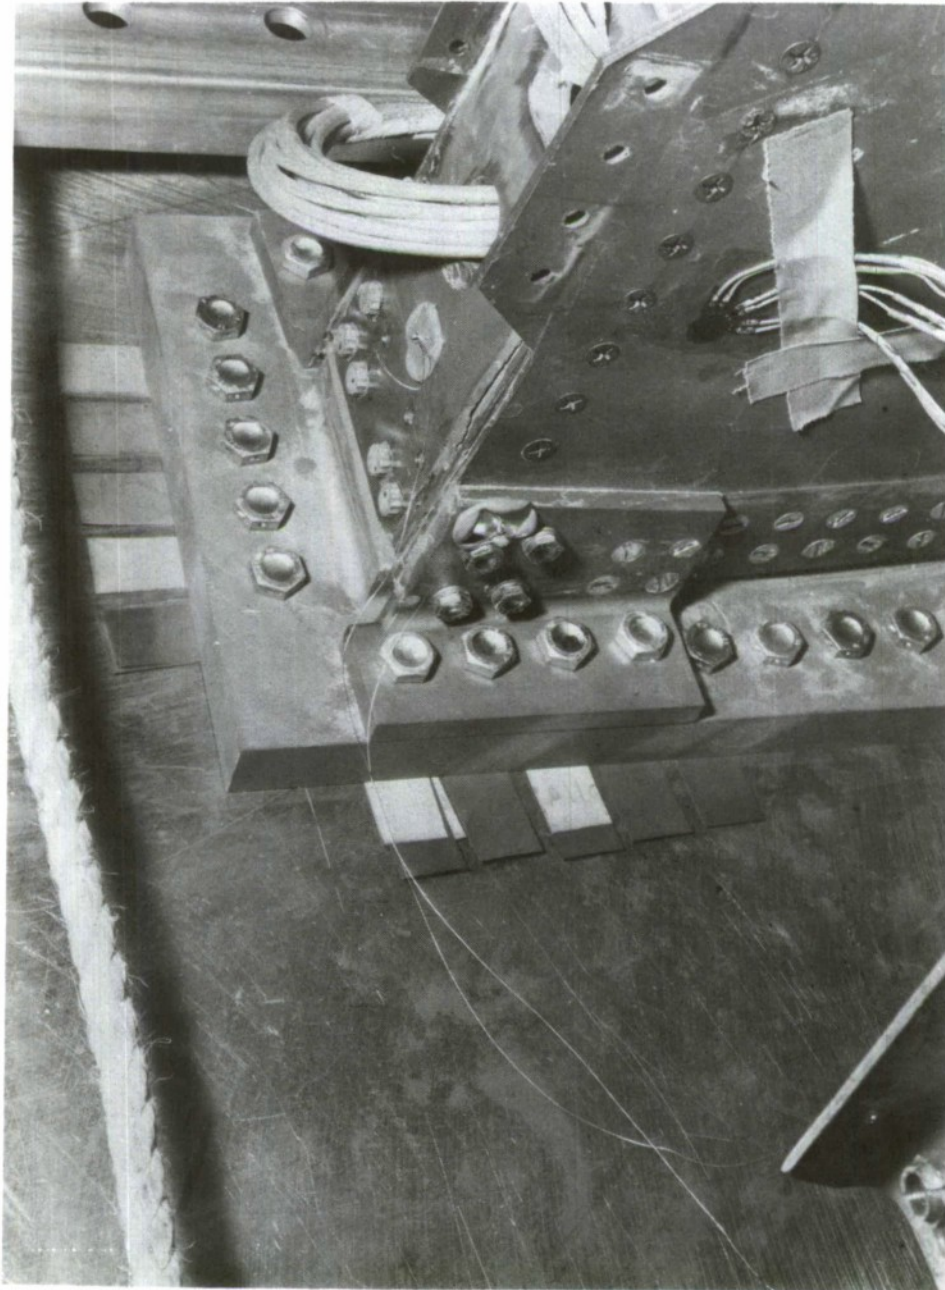
(3) The forward and aft faces of the boron web of the front spar had become unbonded from the core under the titanium doubler plate at the inboard end. Figure 13 shows some of the debonding.

The Block 21 failures were not discovered during the Block 20 inspection since most of the front spar was covered up with loading fixtures. The only visible evidence was a hair line crack in the front spar doubler and a crack in the bond under the doubler in an area not considered critical by the analysis. The Block 20 data were taken on 28 July 1969 and the inspection made the same day and cycling resumed. The damage was discovered 30 July 1969 when some bolts were being checked for tightness. The Block 20 data had not returned from processing when the damage was discovered.

Figure 13. Block 21 Failure Showing Unbonding of Front Spar Doubler

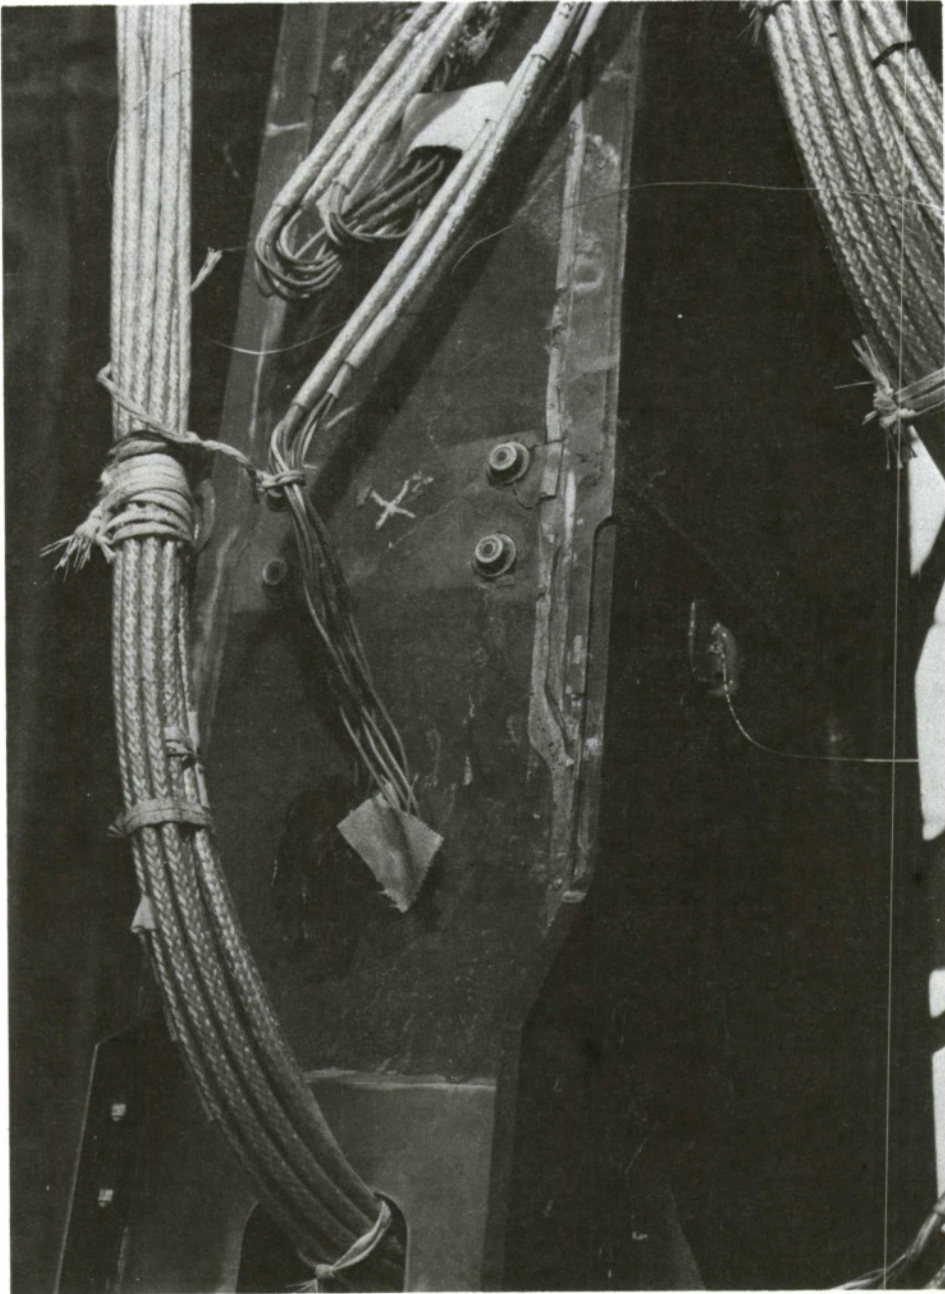
(5) A crack was found in the forward face of the front spar boron web at the mid rib. Figure 14 shows this damage.

Figure 14. Block 21 Failure Showing Cracked Boron on Front Spar at  
Mid Rib

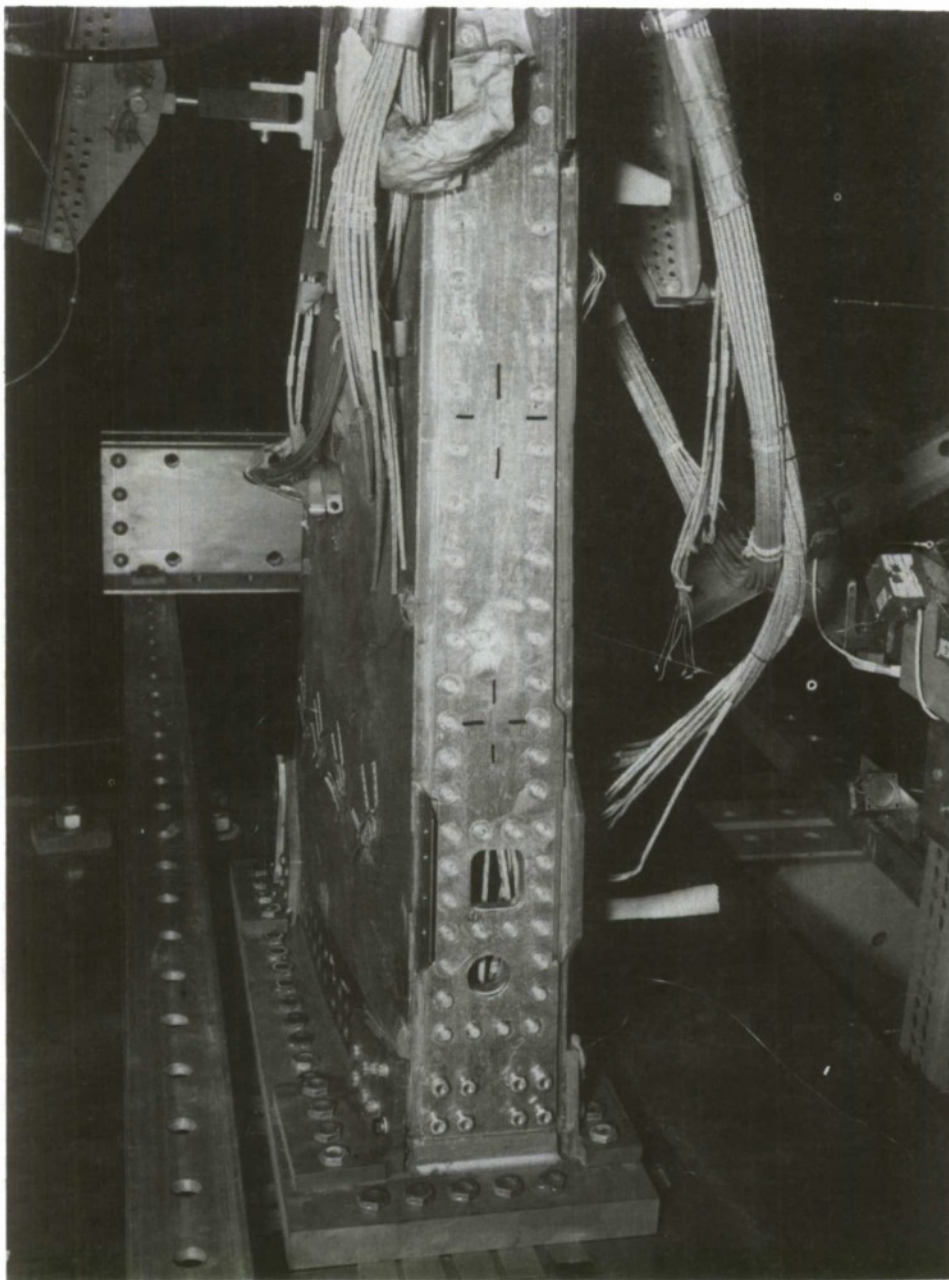
Figure 15. Repair Doubler Installed on Front Spar After Block 21 Failure

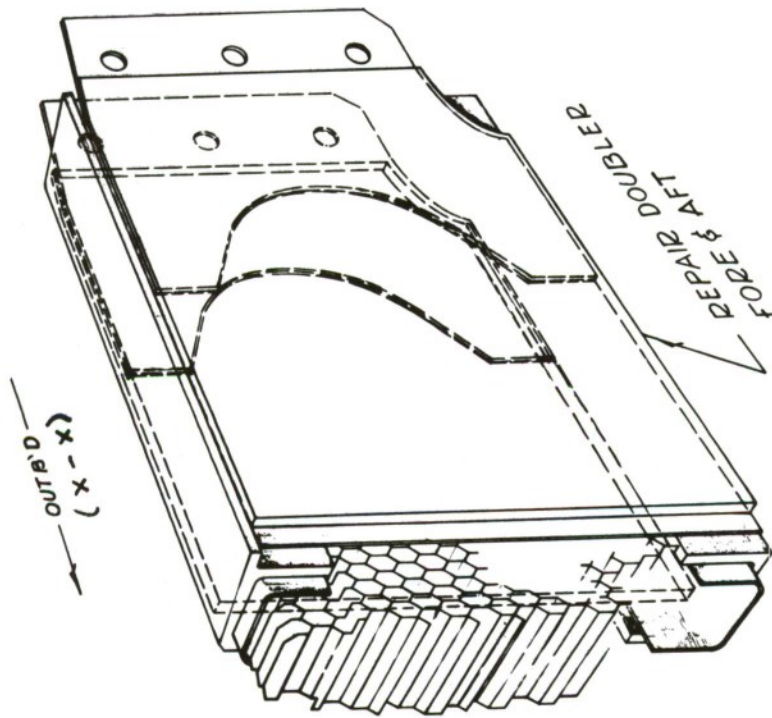
(7) The titanium plate on the inboard end, aft face of the mid spar was debonded from the boron web.

Figure 16. Repair Doubler Added to Center Spar After Block 21 Failure

The mid rib debonding was repaired by adding an 0.060 inch aluminum doubler. Figure 16 shows this repair.

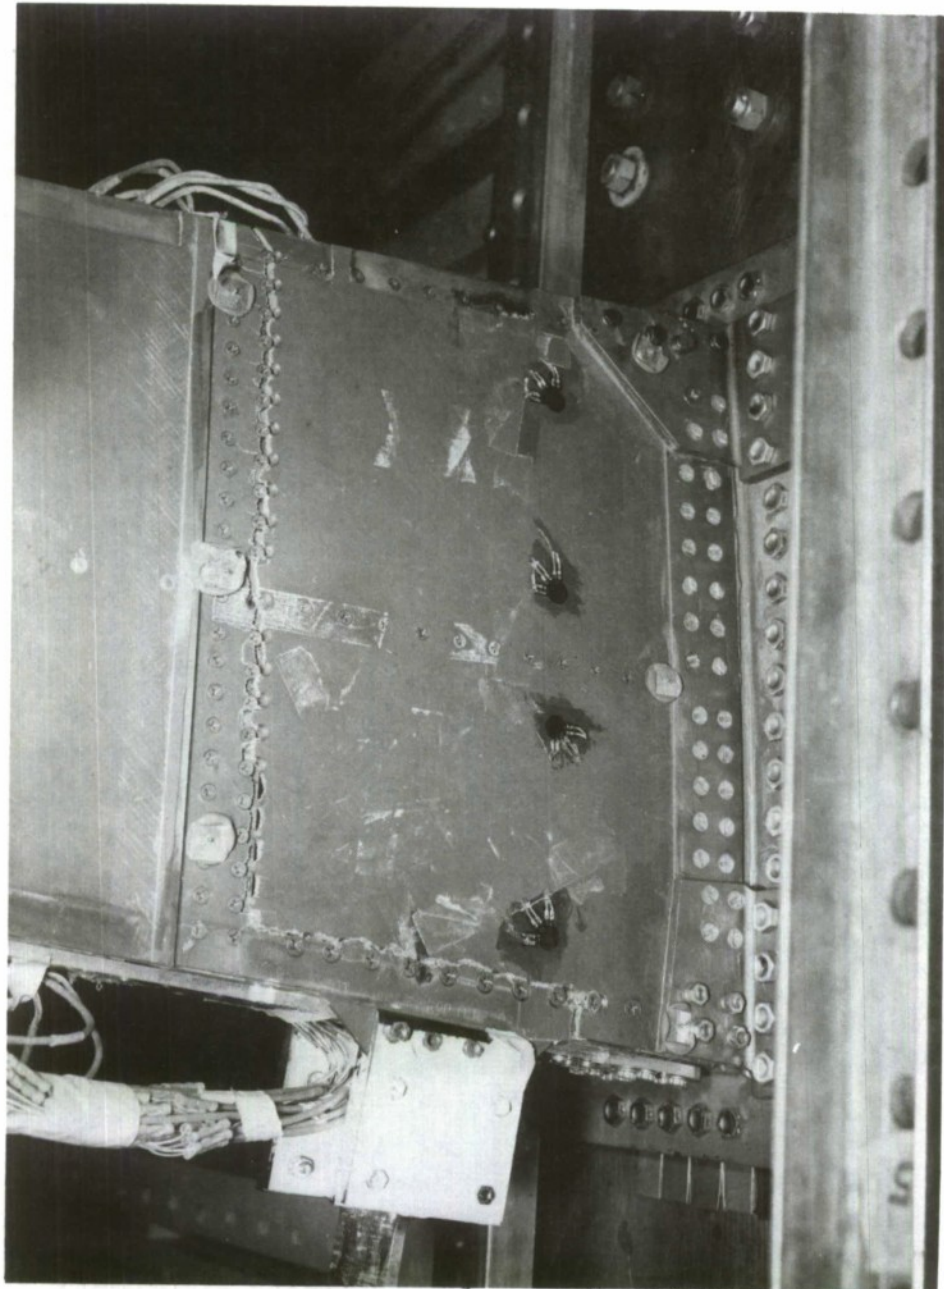
The wing tip successfully sustained 150% DLL for the forward CP positive and aft CP cases with no apparent damage. The forward CP loads were then applied in 10% increments to 125% DLL and 5% increments from then on to failure. The load was held 15 seconds at each increment and the instrumentation was read during the last five seconds. Final failure occurred at 179% DLL through the lower cover at Rib B through the inboard row of fasteners and through the front and rear spars. Figures No. 17, 18 and 19 show the final failure.

Figure 17. Final Failure of Lower Cover

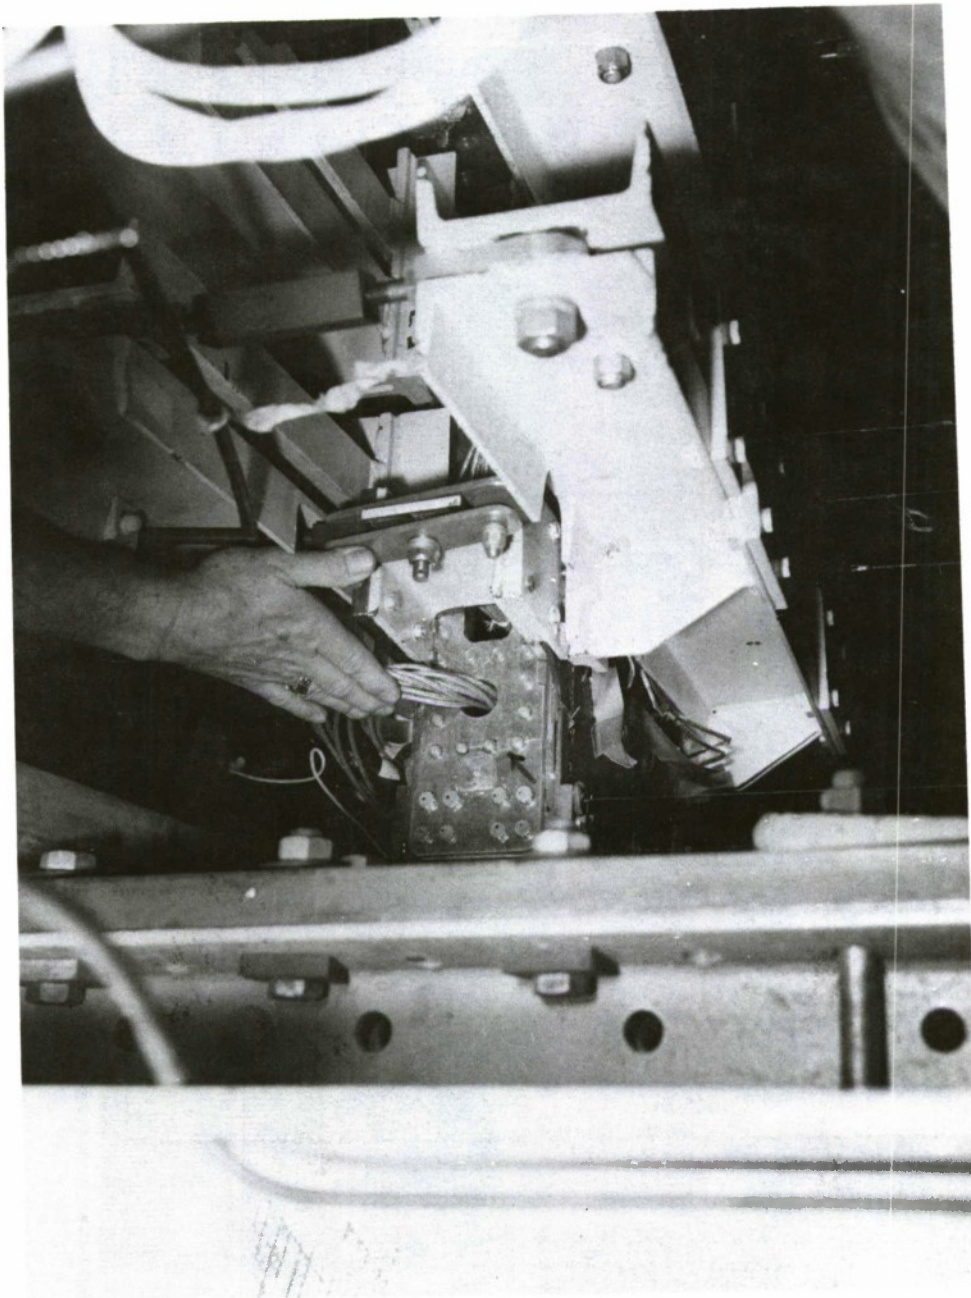
Figure 18. Final Failure of Front Spar Doubler Added After Block 21 Failure

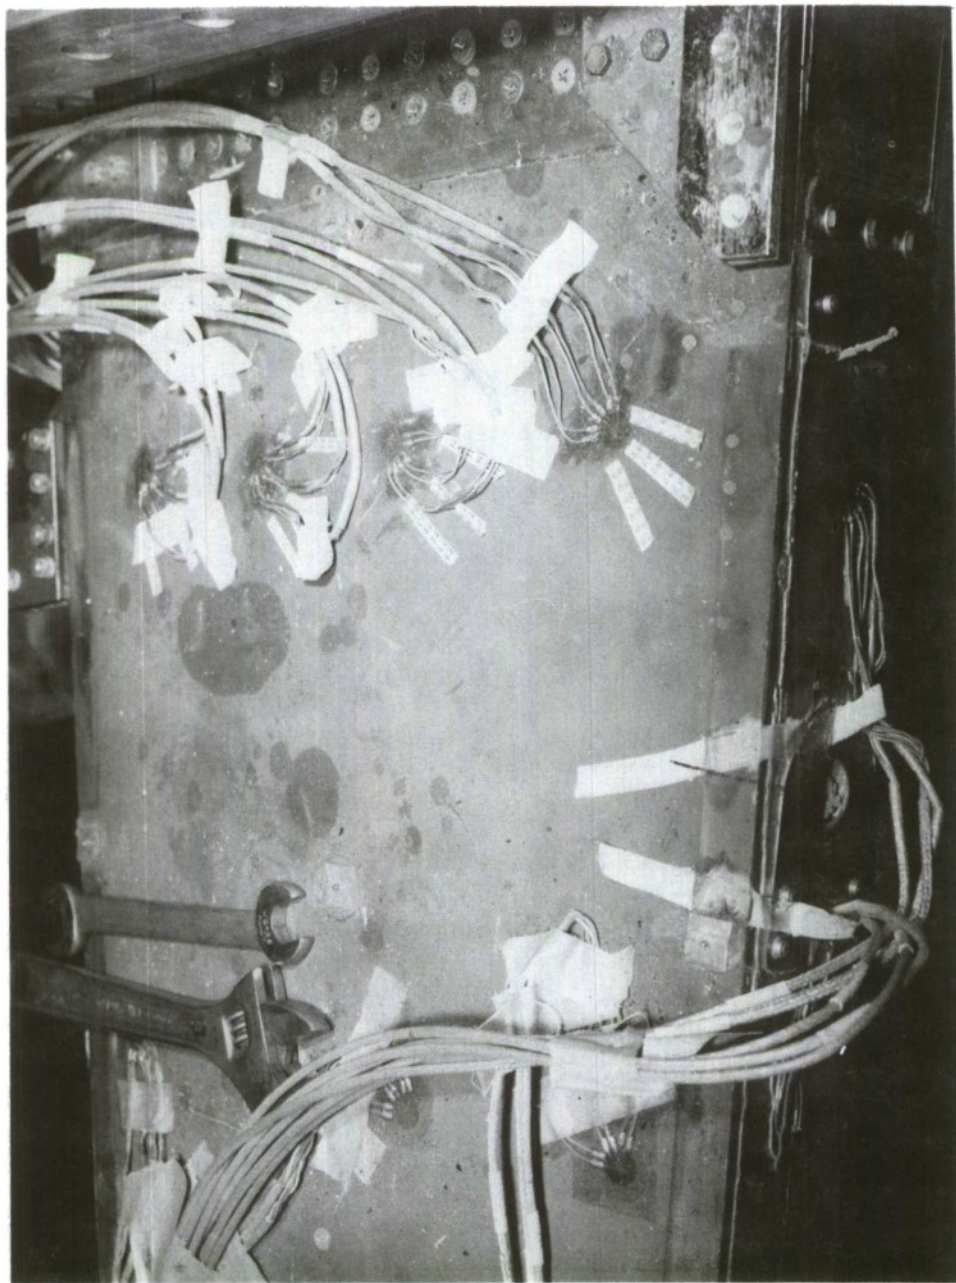
Figure 19. Final Failure of Rear Spar Showing the Core Failure
